Cleaning and Restoration work in "Arches Building", Lod – Preliminary Report

The "Arches Building" is the name of an Ottoman period olive-press facility located in Lod's Old City (190,816/651,168). The building was active from around the late 18th century A.D. until just before the 1948 Israeli Independence War.

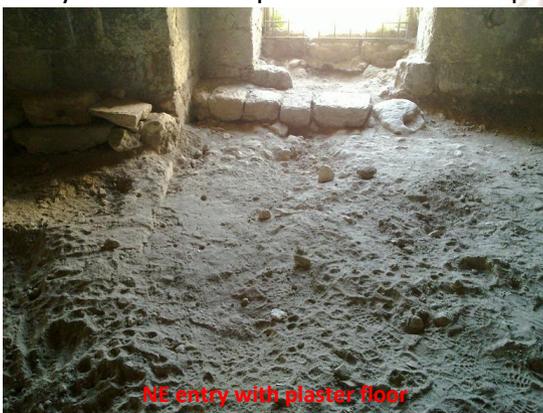
NE entry with plaster floor

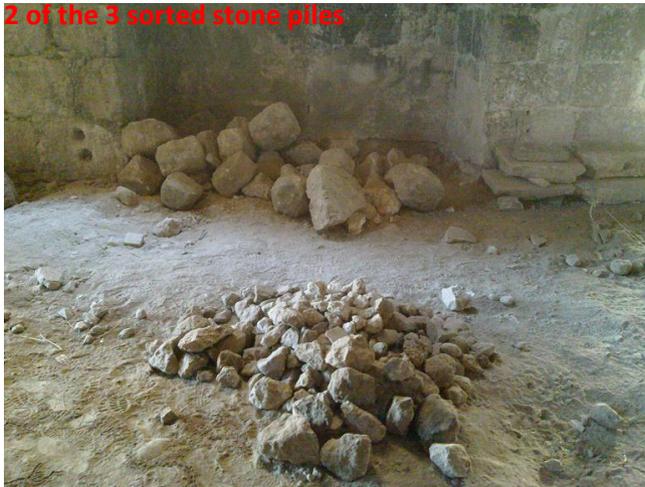
2 of the 3 sorted stone piles

- Approx. 10 tons of waste, garbage and dirt were removed from the interior, and was later carried away to a landfill by the municipality.
- Sealing a large hole in the ceiling as a result of collapse.
- Repair of one of the support columns, to prevent further deterioration
- Collapsed construction stones, worked and un-worked, were piled separated to size groups in order to assist future reconstruction and preservation efforts.
- The creation of a sitting-area for instruction or guiding.
- Exposing the first stone-course of the north-eastern entrance and a plastered entryway adjacent to it.
- Exposing a pebbled installation (?) - floor in the Eastern part of the building.
- Involving three groups of volunteers in a communal project, and instructing them both in the history of the city of Lod, and in the basics of archaeology.

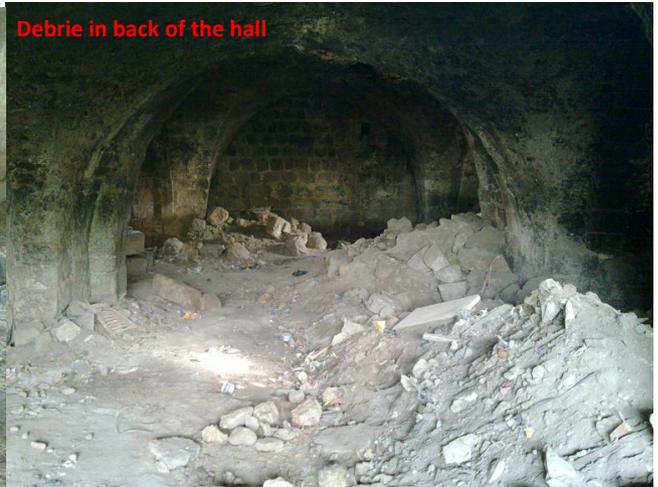
Debris in back of the hall

Next, a group of hired workers removed the main bulk of "dangerous" waste from the interior: rusted metal, syringes, asbestos etc. In addition, the workers removed much of the vegetation and garbage that piled against the outside walls of the building. A "sitting-area", for instructions and conversations, was formed using carved building stones, of one of the collapses, and also the stairs to the roof were blocked, in order to prevent the visitors and volunteers from climbing to the still dangerous roof. Only with the completion of these steps the structure was ready to receive children and adults for volunteer work.

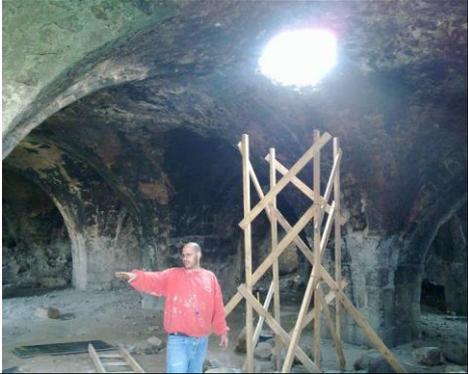
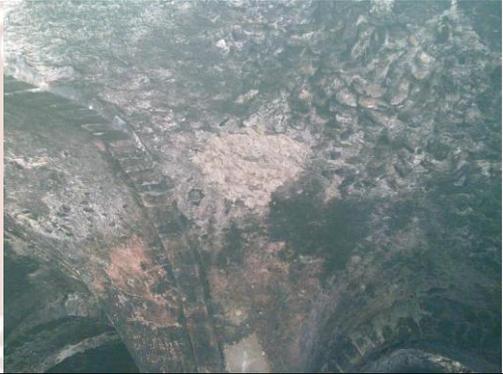
Before	After
The hole in the roof

The first immediate action in the "Arches Building" was a small-scale, yet crucial, preservation task which included sealing gaps in the roof, and filling cavities which formed in one of the arch-columns supporting the structure. This was a measure that had to be taken before introducing other workers and volunteers into the building. (see pictures below)

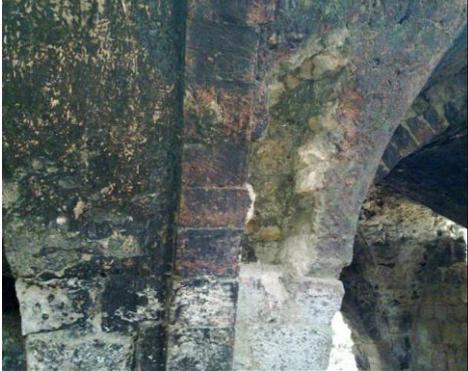
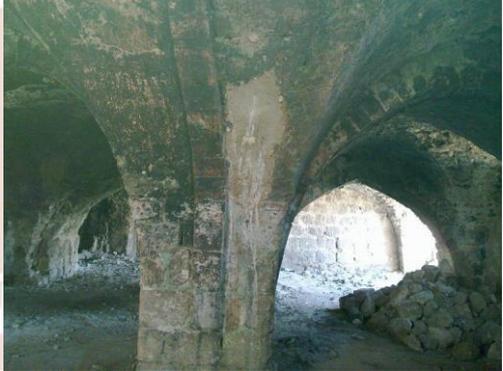
The column
